Degradation of Continuous Fiber Ceramic Matrix Composites Under Constant-Load Conditions

Michael C. Halbig and David N. Brewer
U.S. Army Research Laboratory, Glenn Research Center, Cleveland, Ohio

Prepared for the
Symposium on Environmental, Mechanical, and Thermal Properties and Performance
of Continuous Fiber Ceramic Composite (CFCC) Materials and Components
sponsored by the ASTM Committee C-28 on Advanced Ceramics
Seattle, Washington, May 18, 1999

1. AGENCY USE ONLY (Leave blank)	2. REPORT DATE January 2000	3. REPORT TYPE AND DATES COVERED Technical Memorandum		
4. TITLE AND SUBTITLE Degradation of Continuous Fiber Ceramic Matrix Composites Under Constant-Load Conditions		5. FUNDING NUMBERS WU-242-82-77-00 1L161102AH45

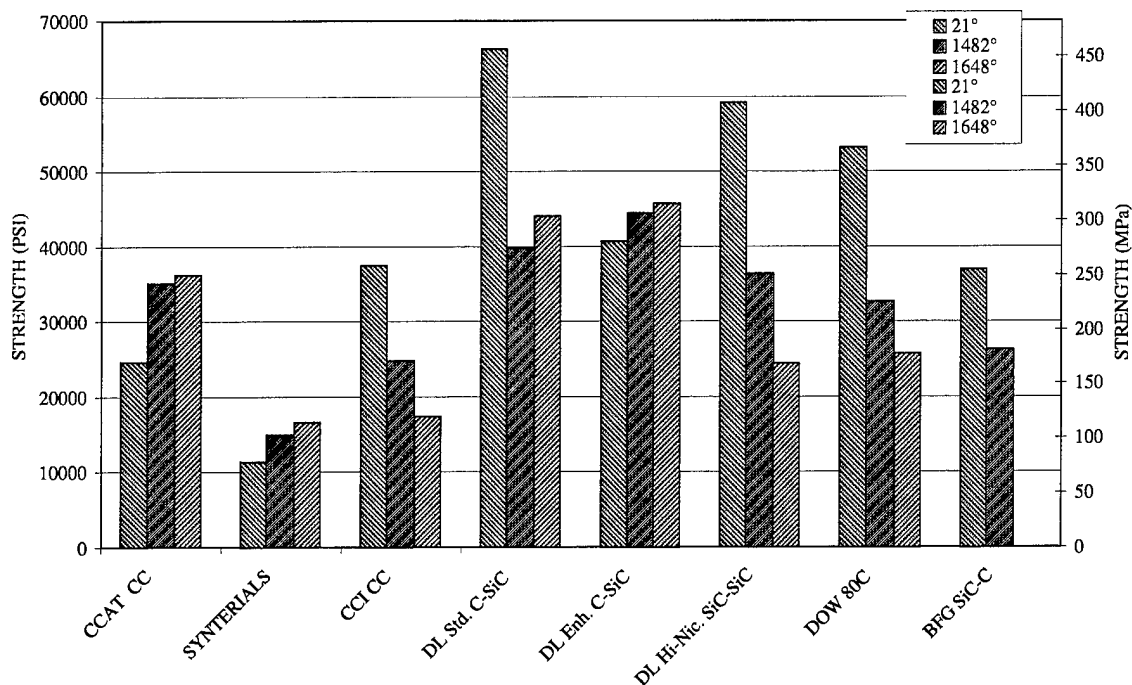
Figure 1—The tensile strength of eight of the program materials at temperatures of 21, 1482 and 1648°C (70, 2700 and 3000°F). Tensile testing conducted by SRI.

In order to interpret better the results of stressed oxidation testing, the ultimate tensile strength of the materials should be known. The results of tensile tests conducted by SRI at 21, 1482, and 1648°C (70, 2700 and 3000°F) are shown in Figure 1. As illustrated by the strengths at elevated temperatures, the C/SiC composites typically have higher strengths than the SiC/SiC composites. The specific C/C materials supplied by the vendors show some variation in strength.

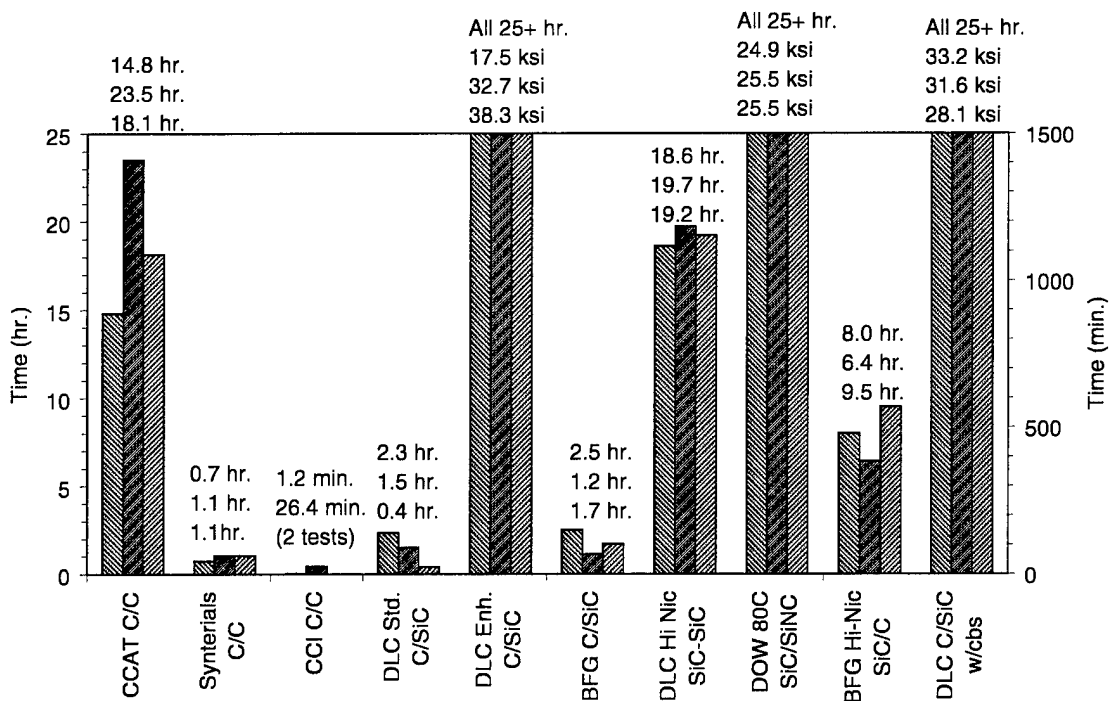
Figure 2—Times to failure for stressed oxidation tests at 1454°C/69 MPa.

The times to failure for the samples stressed oxidation tested at 69 MPa are shown in Figure 2. Three of the materials survived 25 hours of exposure. The three materials (DLC enhanced C/SiC, DLC C/SiC w/cbs, and Dow SiC/SiNC) all had oxidation protection enhancements which, seem to be a key in prolonging the life of both C/SiC and SiC/SiC composites. The DLC enhanced C/SiC material has a boron containing particulate in the composite that acts as an oxygen getter and forms borosilicate glasses that seal cracks and protect the fibers from oxidation. The DLC C/SiC material with a cbs (carbon, boron, and silicon) coating uses a similar method of oxidation protection as the enhanced C/SiC material, however, a boron containing coating also provides an exterior form of protection. The Dow SiC/SiNC uses a proprietary, non-carbon, interphase on the SiC fibers. The three materials had relatively high residual strengths as determined from room temperature tensile tests. Two other materials, CCAT C/C and DLC SiC/SiC, did fail within 25 hr, but had relatively longer lives compared to the five other materials that failed at shorter times.

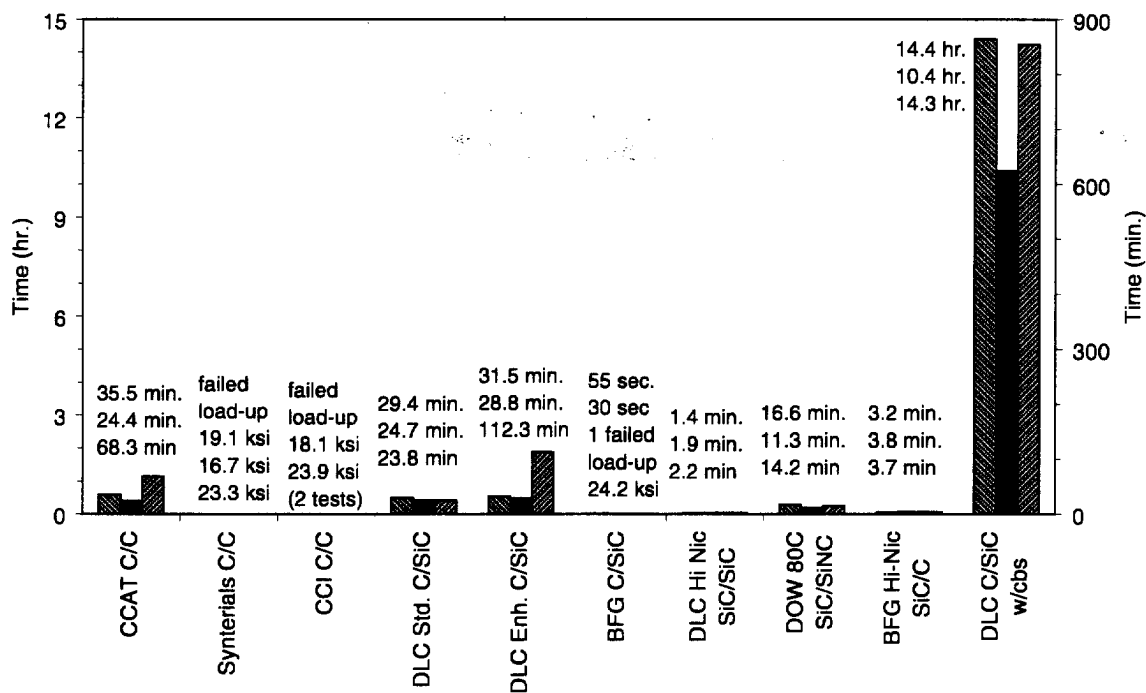
Figure 3—Times to failure for stressed oxidation tests at 1454°C/172 MPa.

The times to failure for testing at a stress of 172 MPa are shown in Figure 3. All of the materials either failed on load-up or had much shorter lives than at 69 MPa with the exception of the DLC C/SiC material with the cbs coating. This material had lives over ten hours while the other materials either failed load-up or had lives of a few minutes or about half an hour. The cbs coating enhancement in the DLC material seems to be effective in sealing cracks and protecting the fibers even at stresses as high as 172 MPa. It should be noted that the DLC enhanced C/SiC and the DLC C/SiC w/cbs materials had failures in a thermal gradient region located in between the heated gage section and the water-cooled grips. This suggests that the enhancements in these materials are effective at our specific temperature of 1454°C, however the materials may be susceptible to degradation at intermediate temperatures.

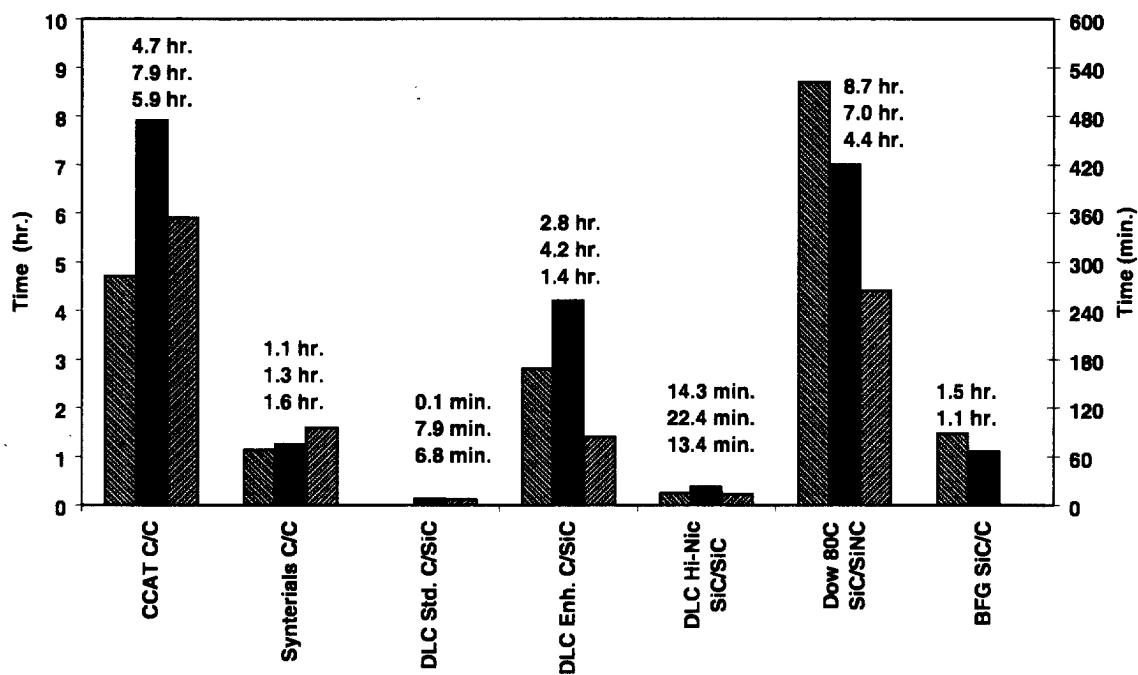
Figure 4—Times to failure for stressed oxidation tests at 1454°C/50% UTS.

Stressed oxidation was also conducted at stresses of 50% of the ultimate tensile strength of each material. The times to failure are shown in Figure 4. Testing at this stress was conducted so that all materials could be evaluated at a stress that seemed to be fairer for all materials regardless of the maturity of the material or the material type. However 50% of the UTS is likely above the first matrix cracking stress for the SiC/SiC and SiC/SiNC materials. Of the seven materials tested at this stress, two materials did better than the rest (CCAT C/C and Dow SiC/SiNC).

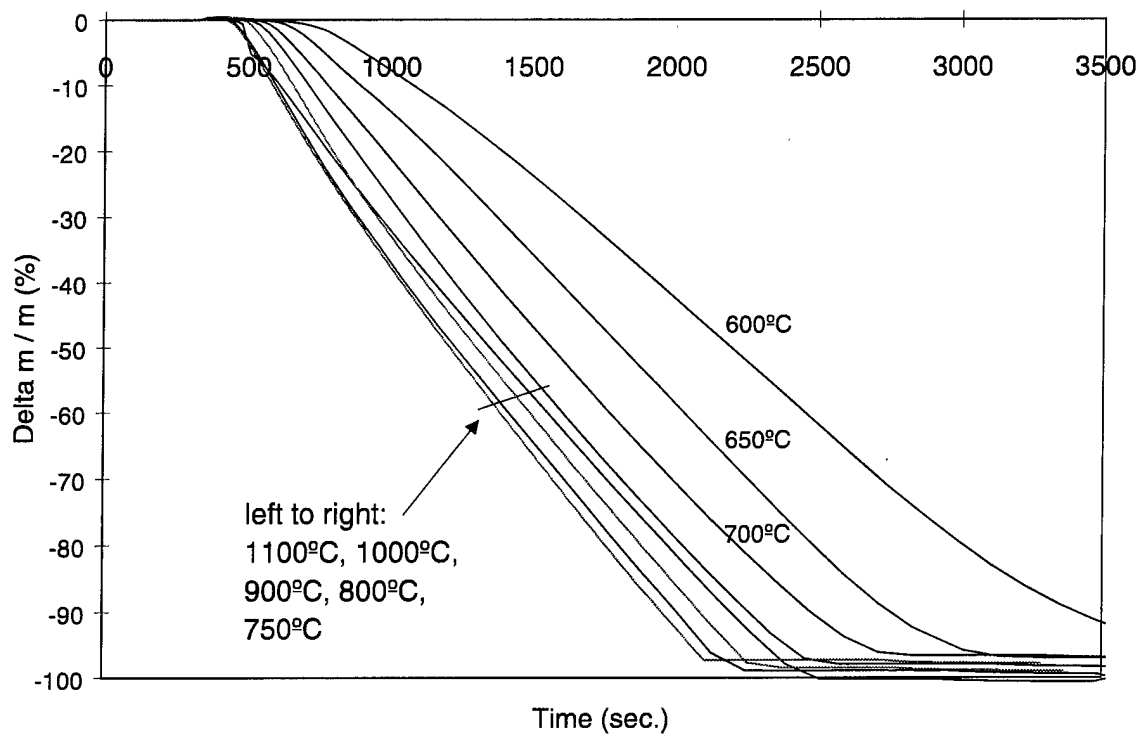
Figure 5—Weight loss versus time of T300 carbon fiber in flowing oxygen at temperatures ranging from 600–1100°C.

Before the effect of a constant load on C/SiC composites is evaluated, it is beneficial to have an understanding of how the material and its fiber constituent behave in unstressed, high temperature, oxidizing conditions. The percent weight loss of T300 carbon fiber versus time at temperatures ranging from 600-1100°C is shown in Figure 5. Slower reaction rates are seen for temperatures ranging from 600-750°C. Faster reaction rates and less of a temperature dependence are observed at temperatures above 800°C. At all temperatures, the approximately 0.4 grams of carbon fiber had completely oxidized away within an hour. These same trends were observed in thermogravimetric analysis (TGA) experiments on T300 fiber conducted by Lamouroux et al [6].

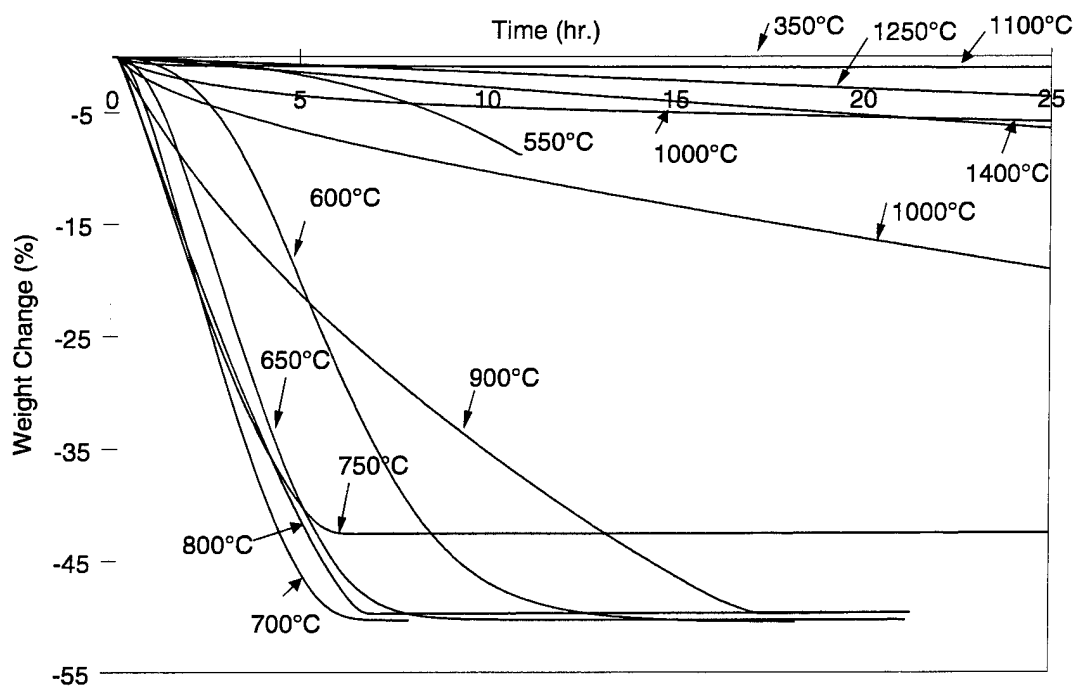
Figure 6—Weight loss versus time of standard C/SiC in flowing oxygen at temperatures ranging from 550–1400°C.

The oxidation of the fully exposed T300 fiber is contrasted by the TGA results of externally-seal coated C/SiC test coupons as shown in Figure 6. At low temperatures, oxygen is able to diffuse into the pre-existing cracks within the composite and react with the carbon fibers. At 550°C, the start of a downward trend in weight loss is observed however the test had to be stopped early. At 750°C, oxidation occurs sooner and at a faster rate. Complete fiber burnout was observed to occur within 5 hours. However, at the higher temperatures, the trends in weight loss and complete fiber burnout did not continue as observed in the TGA tests conducted on the bare T300 fiber. As test temperatures were increased, weight loss rates greatly decreased so that low weight losses were observed even after 25 hours. It should be noted that two tests were conducted at 1000°C and both had different oxidation rates, which are believed to be due to the difference in pre-existing cracks in the external seal coating. Microstructural analysis of polished cross-sections revealed that one sample oxidized uniformly from the outer edges toward the interior while in the other sample significant oxidation occurred from one edge toward the interior but at the opposite edge little oxidation occurred.

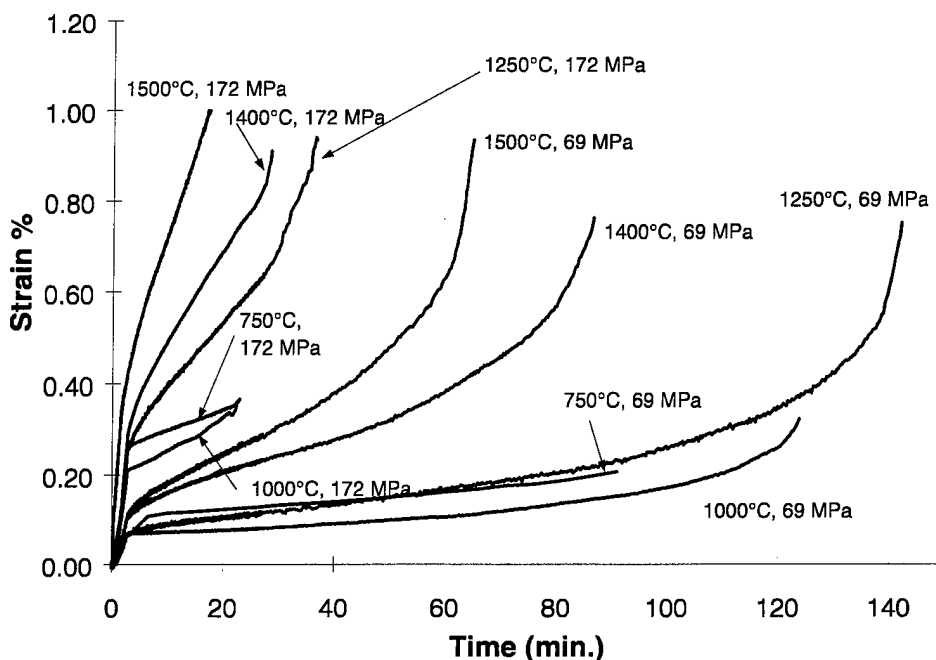
Figure 7—Strain versus time curves from stressed oxidation testing of C/SiC at stresses of 69 MPa (10 ksi) and 172 MPa (25 ksi) and temperatures from 750–1500°C.

When a constant load is applied to C/SiC at elevated oxidizing temperatures, the applied stress opens existing cracks and allows for easier ingress of oxygen to the fibers. At sufficiently high stresses, cracks may be open too wide for crack closure and sealing to occur. The results of stressed oxidation of DLC's standard C/SiC material at stresses of 69 MPa and 172 MPa and at temperatures ranging from 750°C-1500°C are shown in Figure 7 [11]. This batch of material is two years older than the DLC standard C/SiC material tested under the NASA MSFC CMC Material Robustness Program.

In the strain versus time curves, the effect of stress can be seen. As expected, the samples tested at the higher stress had shorter lives. The samples tested at 172 MPa had curves that fall to the left side of the plot while the samples tested at 69 MPa had longer lives and were concentrated to the right side of the plot. Although the times to failure across the temperature range occurred within a fairly narrow range, times to failure increased from 750°C to 1250°C and then decreased at temperatures higher than 1250°C for both stresses. Another effect from temperature is the strain to failure. Samples tested in the higher temperature range showed a much more pronounced tertiary regime and higher strains to failure.

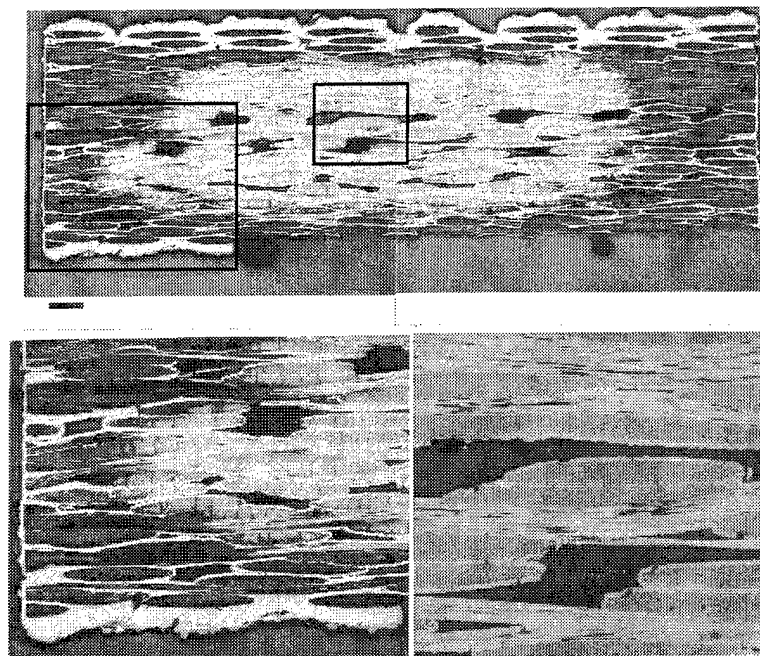
Figure 8—Diffusion controlled kinetics. Optical micrograph of a polished cross-section of a C/SiC sample stressed oxidation tested at 1400°C/69 MPa. Time to failure was 86 minutes. Scale bar in top micrograph equals 0.5 mm.

The model was run at values (i.e. reaction rate constant, diffusion coefficient, and total oxygen concentration at the edge) correlating to conditions at 1400°C in air, and was compared to the microstructure of a tested coupon. Figure 8 shows the polished cross-section of a sample that had been stressed oxidation tested at 1400°C/69MPa. Severe carbon consumption is seen around the perimeter of the sample (darkened regions in the micrograph). In the close-up views, a reaction front can be seen as carbon is immediately oxidized as soon as oxygen is supplied so that the interior is starved in oxygen and no oxygen is present to react with carbon in the interior of the matrix. In the close-up view of the interior, a large void and cracks in the fiber tows are seen, however, no evidence of oxidation is observed. The oxidation patterns shown in Figure 8 suggest a steep gradient in oxygen concentration at the reaction front toward the interior of the sample. This is an oxidation pattern that would be expected from diffusion controlled kinetics. The results from running the model at conditions for 1400°C are shown in Figure 9. The oxidation pattern on a 2-dimensional surface within the fiber bridged region is shown at various stages in the top row of plots. A shrinking core effect is seen as fibers on the outer perimeter are consumed first and then the reaction front moves inward to the next perimeter of fibers. The interior fiber tows remain unreacted until the oxygen supply reaches them. The correlating oxygen concentration plots for one-quarter of the 2-dimensional section are shown in the bottom row. A steep gradient in oxygen concentration can be seen at the edge of the reaction front

toward the interior of the sample. The interior is shown to be deprived of oxygen. These patterns agree well with experimental observations and suggest diffusion controlled kinetics at this relatively high temperature.

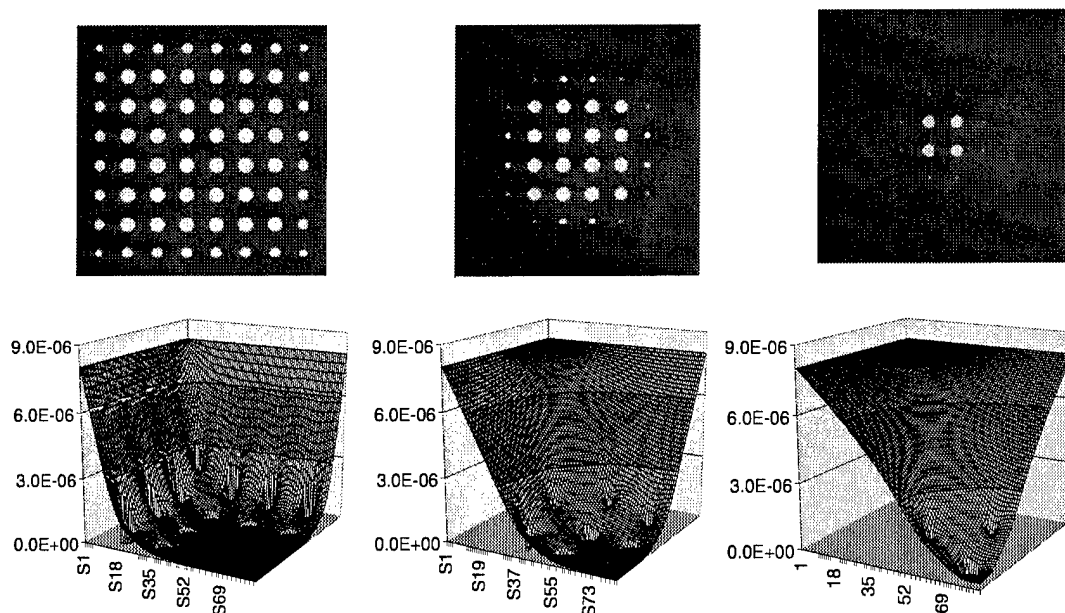
Figure 9—Diffusion controlled kinetics for $Sh = 1.07$ (relating to 1400°C) at 25%, 75%, and 95% carbon consumption of the 8×8 fiber array. The top illustrations are of the remaining area of carbon on the 2-dimensional surface. The bottom plots are of the related oxygen concentrations (mol/cm^3) for one quarter of the surface.

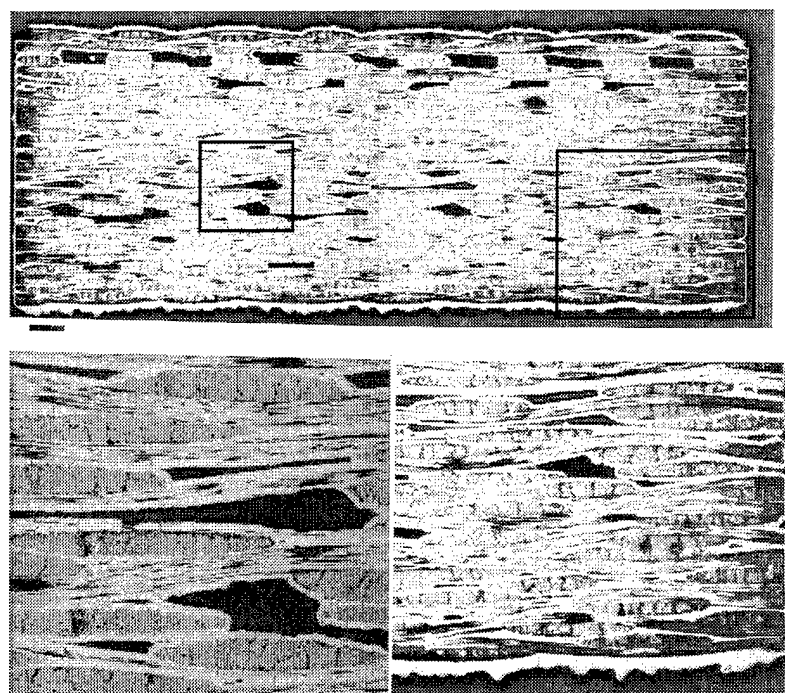
Figure 10—Reaction controlled kinetics. Optical micrograph of a polished cross-section of a C/SiC sample stressed oxidation tested at $700^{\circ}\text{C}/69 \text{ MPa}$. Time to failure was 91 minutes. Scale bar in top micrograph equals 0.5 mm.

The model was also run at values correlating to conditions at 700°C, and were compared to the polished cross-section of a test coupon that had been stressed oxidation tested at 750°C. Figure 10 shows the polished cross-section of a sample stressed oxidation tested at 750°C/69 MPa. Minimal and uniform oxidation is seen along the edge of the sample as well as deep in the interior of the sample along the edges of fiber tows (bundles) and along the matrix cracks within the tows. This pattern suggests that the carbon/oxygen reactions are so slow that oxygen is able to bypass the carbon at the outer edge and saturate the interior at high concentrations so that oxygen is available throughout the matrix to supply the slow reaction process. This is the oxidation pattern that would be expected for reaction controlled kinetics. The results from running the model at conditions for 700°C are shown in Figure 11. The oxidation pattern of the bridging fiber tow array on the 2-dimensional surface is shown in various stages in the top row of plots. The correlating oxygen concentration plots for one-quarter of the section are shown in the bottom row. Uniform carbon reactions and high oxygen concentration are seen throughout the 2-dimensional surface of the matrix. These patterns agree well with experimental observations and suggest reaction controlled kinetics at this relatively low temperature.
